**Field manual:
postearthquake safety
evaluation of buildings**

ATC-20-1

**Field Manual: Postearthquake Safety
Evaluation of Buildings
Second Edition**

by
APPLIED TECHNOLOGY COUNCIL
201 Redwood Shores Pkwy, Suite 240
Redwood City, California
www.ATCouncil.org

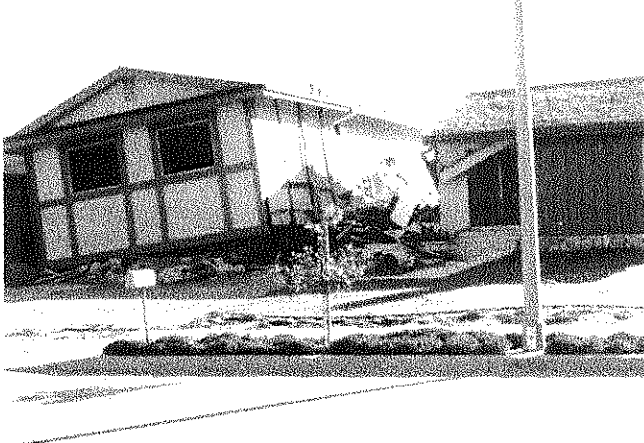
Condition 1: Collapse, partial collapse, or moved off foundation. Post Unsafe.

Figure 3-1 Examples of "Unsafe" buildings or situations using Rapid Evaluation criteria.

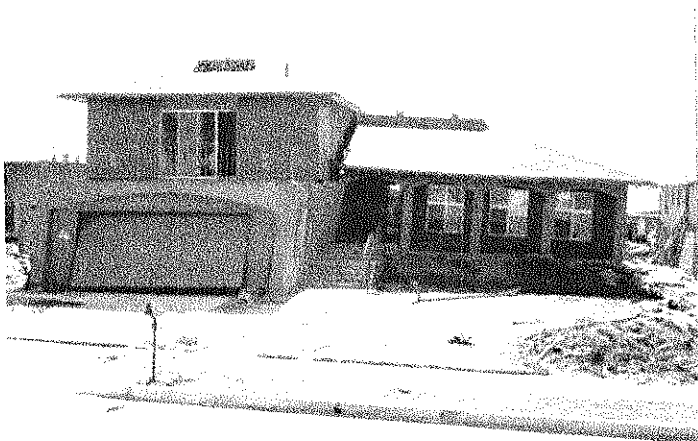
Figure 5-2 There is residual lean in the garage opening and separation between portions of the structure. Post Unsafe.

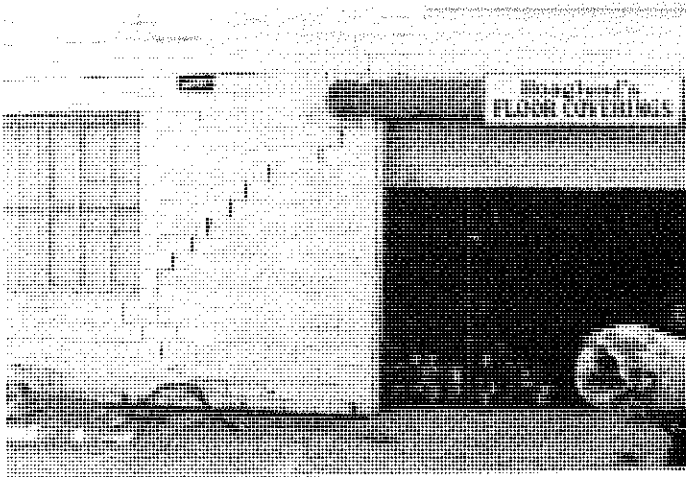
Figure 6-5 Unreinforced masonry wall with a stepped crack.

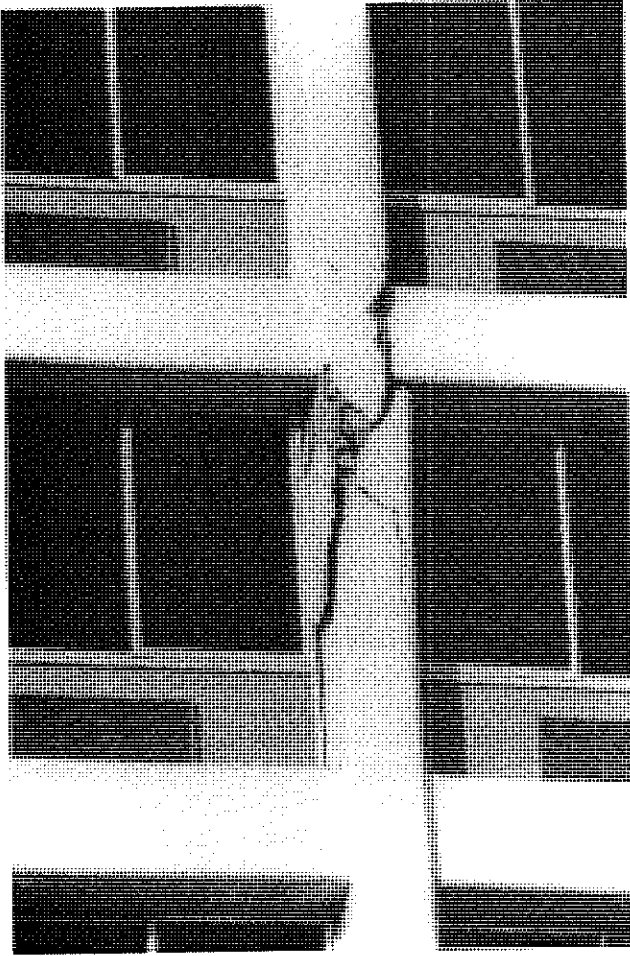
Figure 8-5 Close-up of fractured column. This column lacks confinement of its vertical reinforcement and has essentially lost its capacity to carry vertical loads. Post Unsafe.

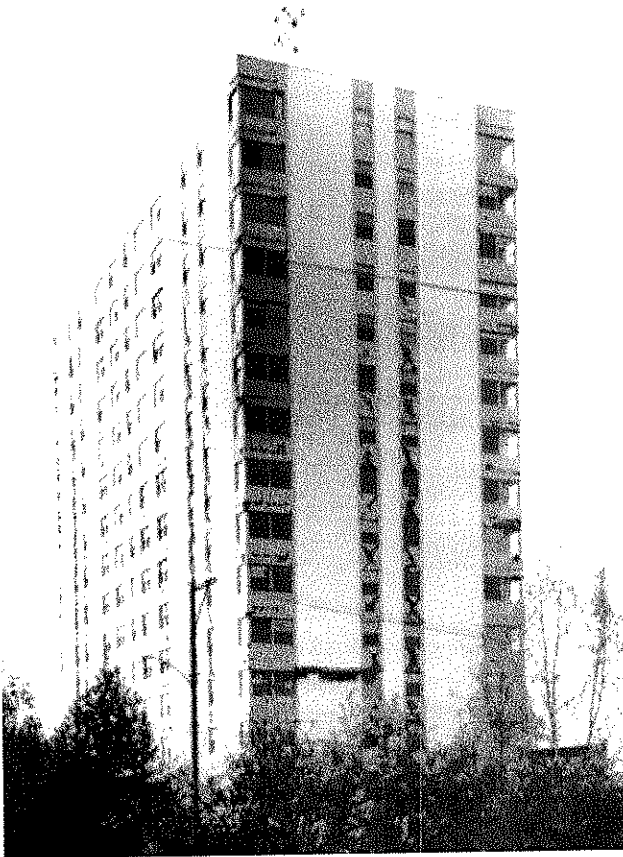
Figure 8-11 Shear-wall failure from 1964 Alaska earthquake. Post similarly damaged structures Unsafe.

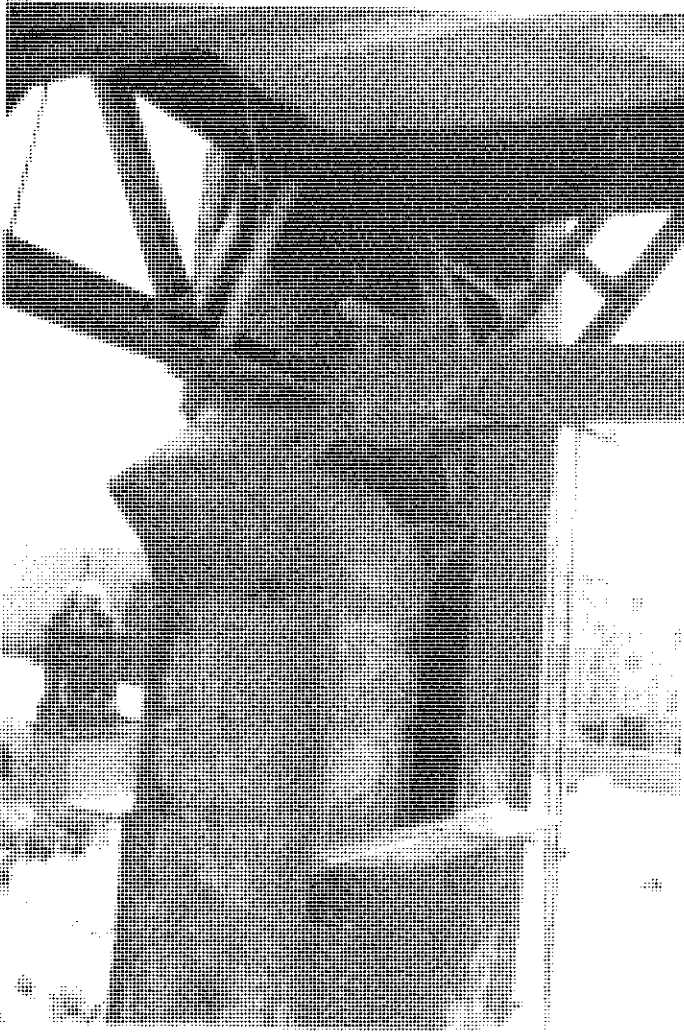
Figure 9-4 Local column buckling of this type constitutes a clearly unsafe situation. Post Unsafe.

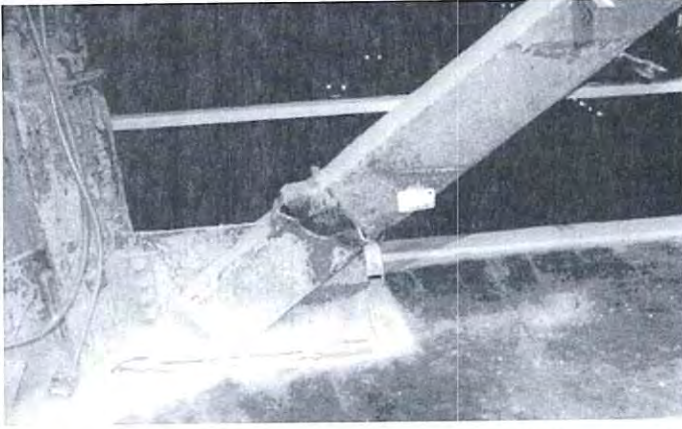
Figure 9-7 This steel tube brace has completely failed. There were few signs of distress until the wallboard finish and fireproofing were removed.

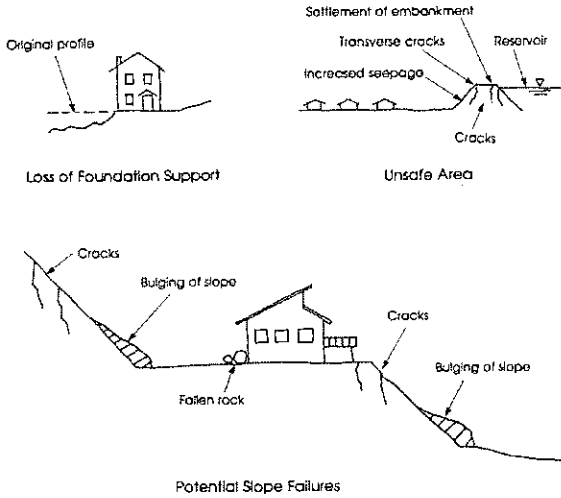
Figure 11-2 Inspection points for some geotechnical hazards.

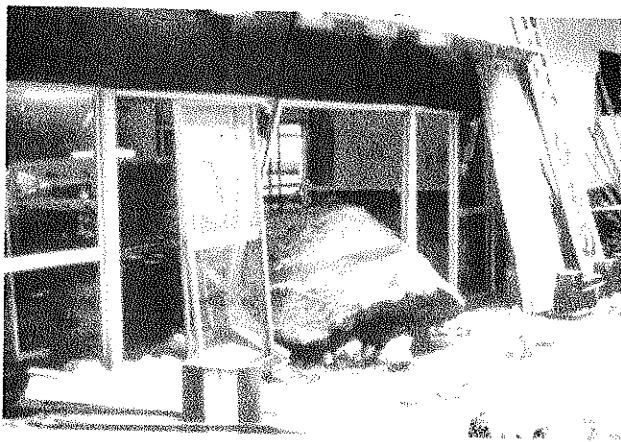
Figure 11-5 Damage to store front caused by rock fall.

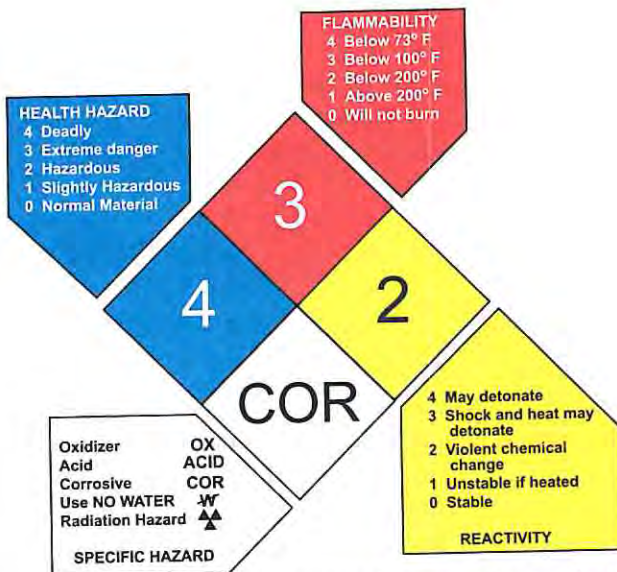
Figure C-1 The National Fire Protection Association has an identification system for hazardous materials. The sign shown above indicates health hazards (left), flammability (top), reactivity (right), and specific hazard (e.g., reactivity to water) (bottom) for one specific chemical. Hazards are rated from 0 (lowest) to 4 (highest and most dangerous).

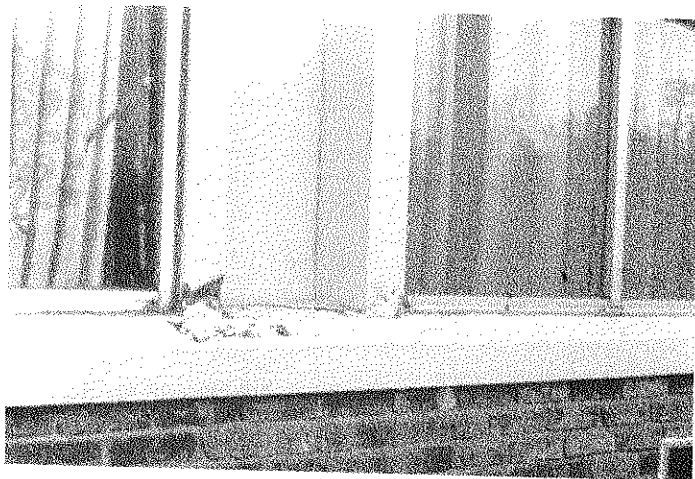
Figure E-5 Spalling at mullion, Example 2.

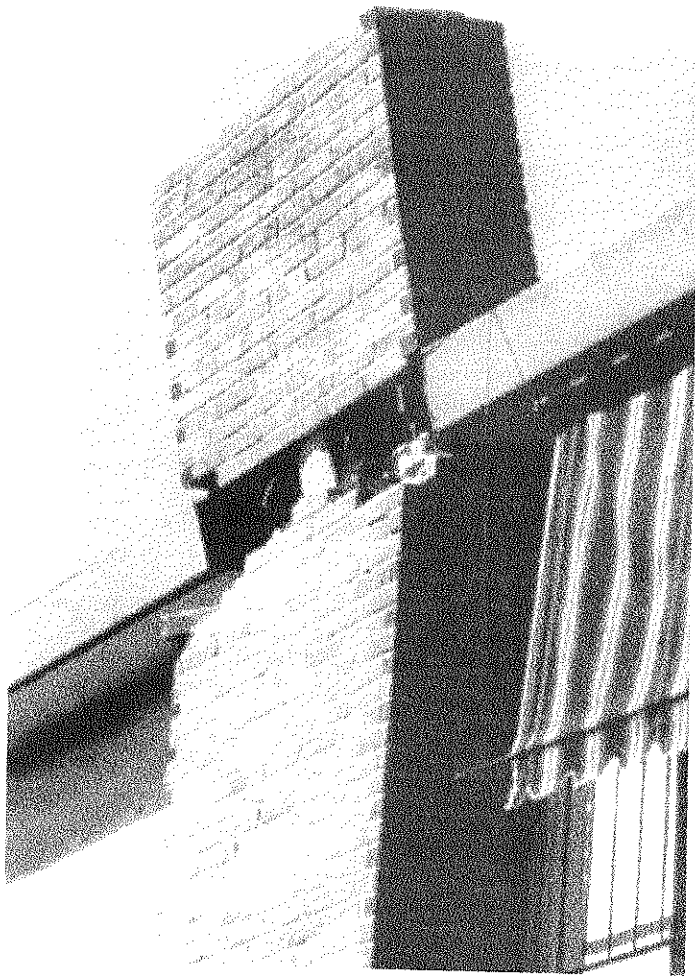
Figure E-11 This leaning chimney from Example 3 has been severely damaged and presents a serious falling hazard. (Note: In some cases, chimneys may be in danger of falling through the roof into the dwelling. In such cases, interior spaces should be barricaded.)

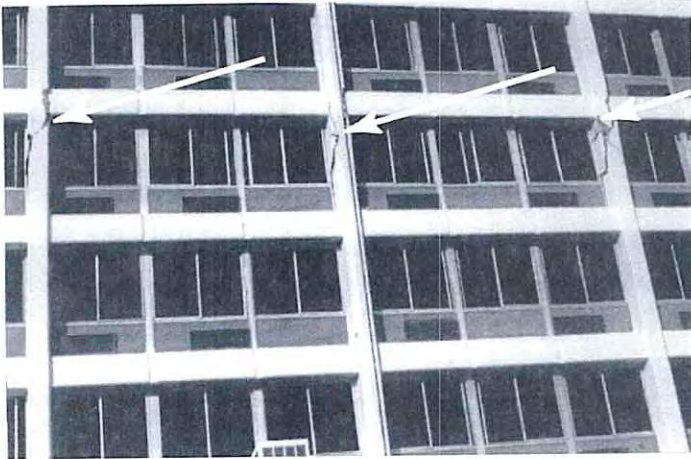
Figure E-16 Columns between the fourth and fifth floors are fractured, Example 4.

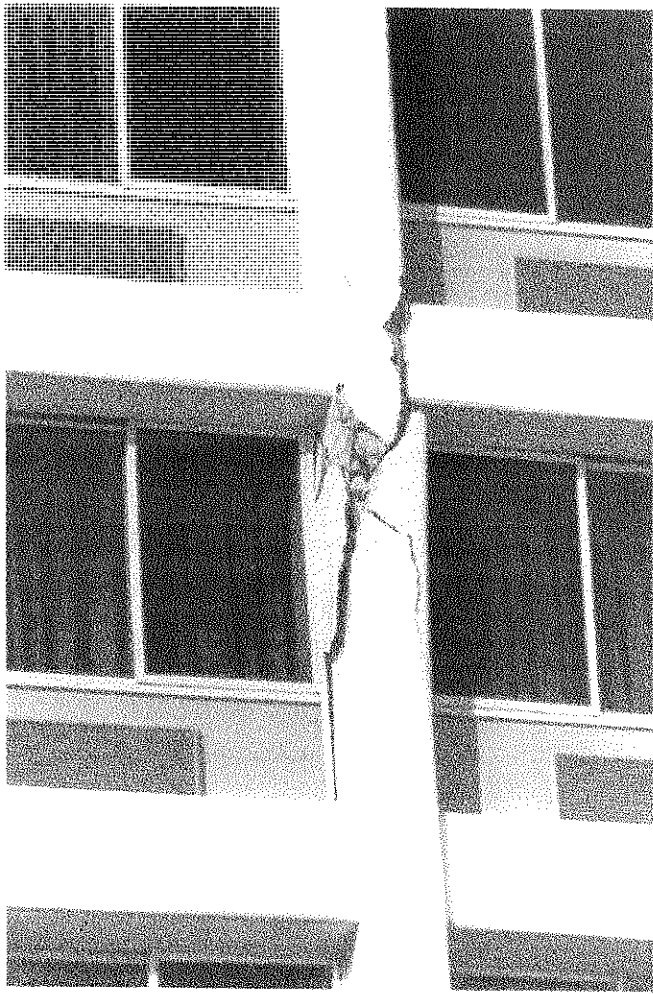
Figure E-17 Close-up of fractured column from Example 4. This column, which lacks confinement of the vertical reinforcement, has essentially lost its capacity to carry a vertical load.
